10. Gasoducto Del Rio

10.1 Pipeline Overview

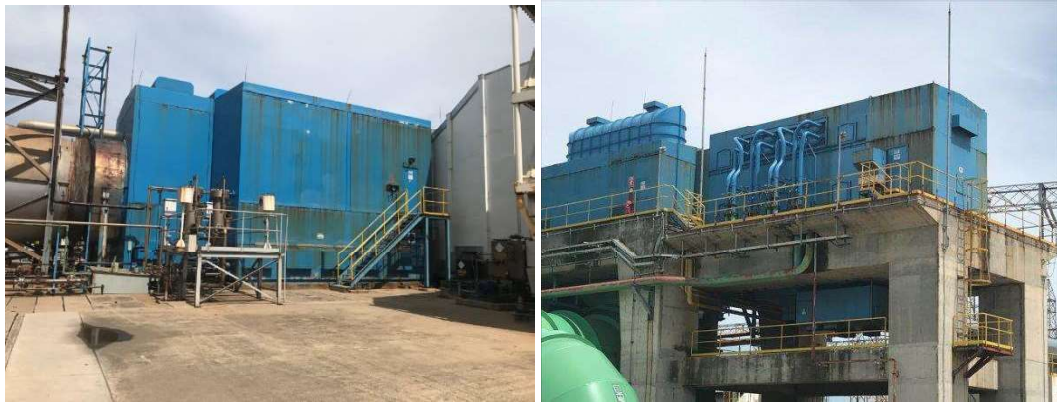
Figure 9-10: Steam Turbine Generator (Left) and Gas Turbine Generator (Right)

Parameter	GT Generator	ST Generator
Model	MHI	MHI
Rated Power (MVA)	170.628	189.308
Cooling System	Air-cooled	Air-cooled
Power factor	0.90	0.90
Voltage	16.5kV	16.5kV

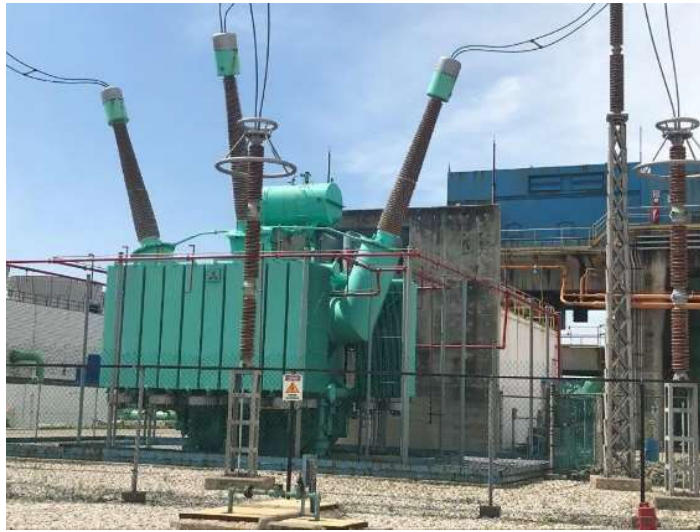
Figure 9-11: Altamira II Transformer

There are three generator step-up transformers (“GSU”) at the Altamira II site; one for each of the gas turbine generators and one is for the steam turbine. The GSU takes the generator voltage and increases it to match transmission voltage. All GSUs at the Altamira II site are oil natural air natural (“ONAN”) and oil forced air forced (“OFAF”). This means that the transformers are cooled by both natural air and oil as well as forced air and oil where the forced flow is caused by fans and motors.

All three GSUs at the Altamira II site are manufactured by Mitsubishi. The specifications for the transformers on site are provided in Table 9-7. An image of a transformer at the Altamira II site is provided in Figure 9-11.

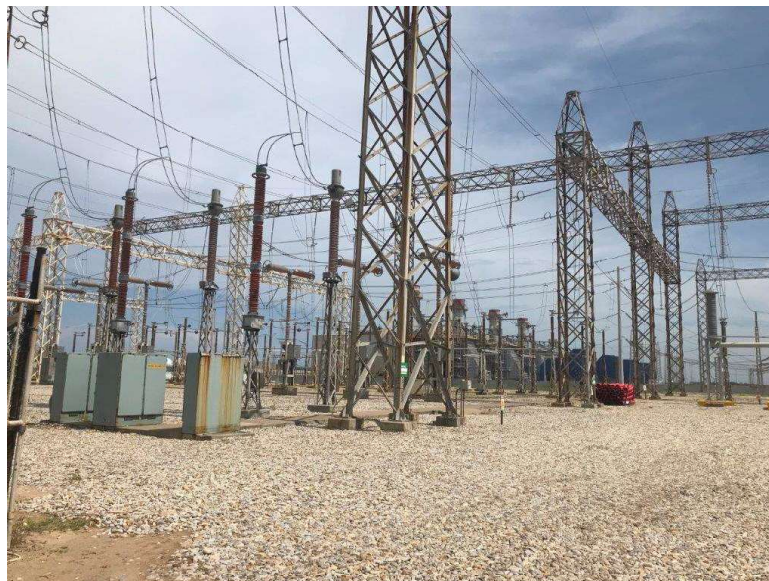
Figure 9-12: Altamira II Substation

After voltage is stepped up at the three GSUs, the power goes to the high voltage switchyard which collects the power from the gas turbine and steam turbine at 400kV. The switchyard is a 400kV air insulated switchgear ("AIS"). The Client replaced and commissioned as new gas insulated switchgear ("GIS") in November 2020. This power is then transmitted to a CFE substation which connects to Mexico's electricity grid. Figure 9-12 shows the switchyard at the Altamira II site.

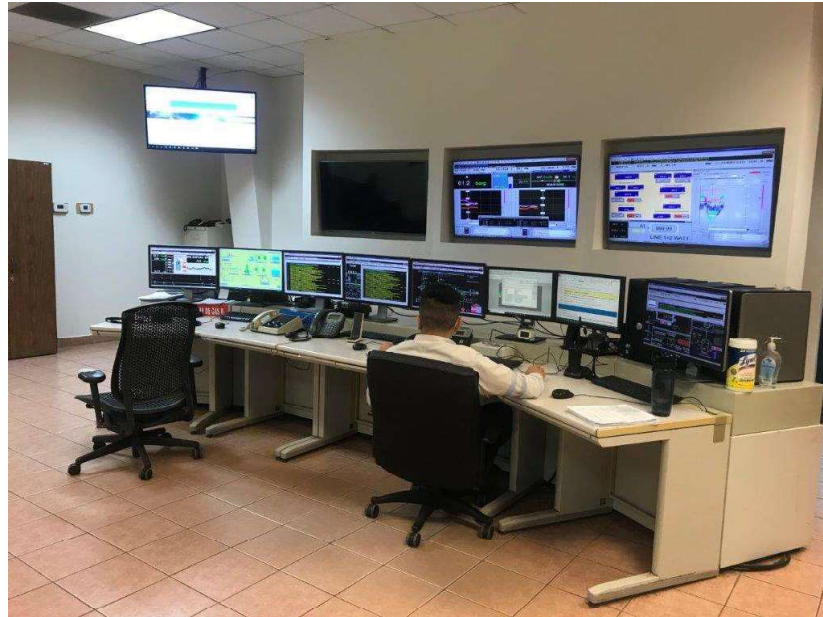
Figure 9-13: Control Room at Altamira II

The Distributed Control System (DCS) is a system of sensors, controllers, and associated signal processing units that are distributed throughout the plant systems. Each of these elements take part in data acquisition, process control, as well as data storage and graphical display. In Altamira II, the current DIASYS control system was upgraded in 2020 as part of the major inspection.
